## CSKT Water Quality Monitoring History

## Moiese Wasteway Rehabilitation

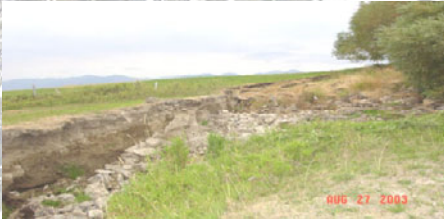
Walchuk Coulee -- 2003

- High TP, TN, TSS
- Low Dissolved Oxygen
- Extreme erosion due to head cutting

Eliminated primary sediment source -- 10 foot vertical eroding banks  
Installed sediment collection pond  
Installed PVC pipe to deliver return flows to Walchuk coulee

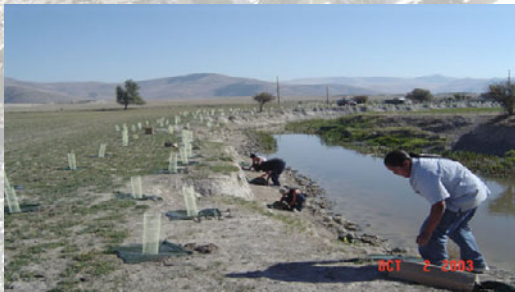
### Christensen Ranch Restoration

2000 plants - 70% survival at 2 years   Fencing - water gap  
Offsite water   Shade tree planting

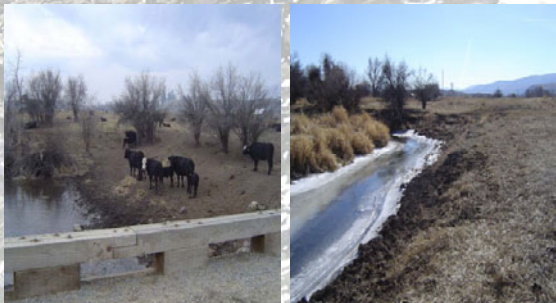
### Recently Funded Project - McDonald Ranch

- Fencing and water gaps to protect restoration plantings and allow degraded areas to recover
- Natural channel design
  - stabilize eroding banks
  - develop more functional stream morphology
- Planting of native woody plant species
